**Elliott Bay/Duwamish Restoration Program:
Year 1 Intertidal Habitat Projects Monitoring Report**

June 2002

Report prepared for the Elliott Bay/Duwamish Restoration Program Panel

U.S. Fish and Wildlife Service

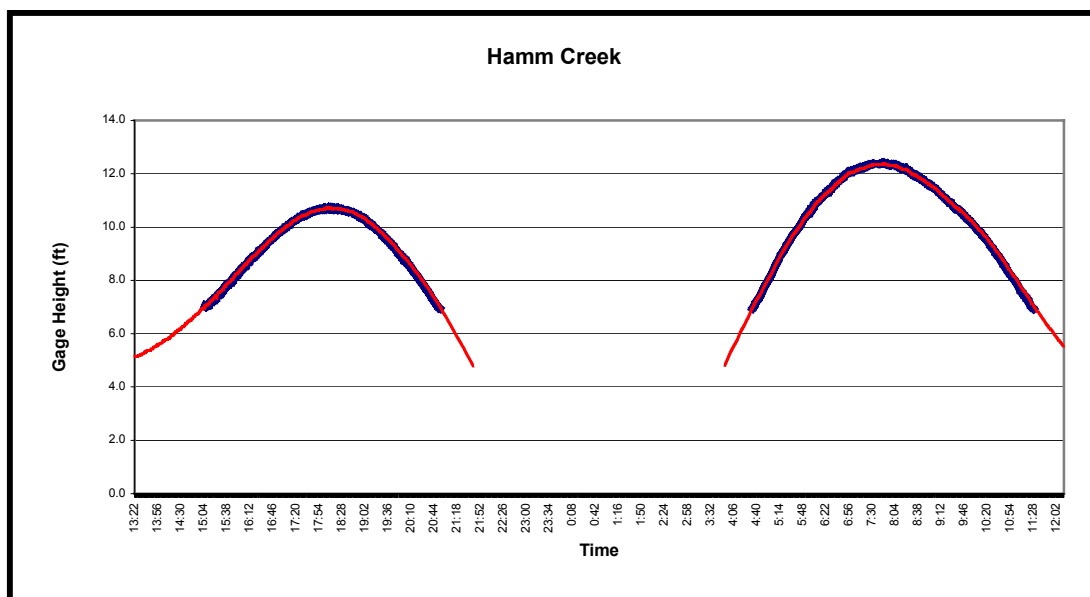
Figure 2a. Tidal regime at Hamm Creek Estuary restoration site (blue line) and in the mainstem Duwamish River adjacent to the restoration site (red line), January 31, 2002.

During the second survey, the timing and magnitude of the tidal cycle at both restoration sites and the Duwamish River adjacent to each restoration site were virtually the same (Figures 2a, 2b). Discontinuities in the gage readings were due to the gages becoming dewatered at lower tides. The current tidal connections of both the Hamm Creek and Herring's House restoration sites are adequate to allow for the full range of tidal timing and magnitude.

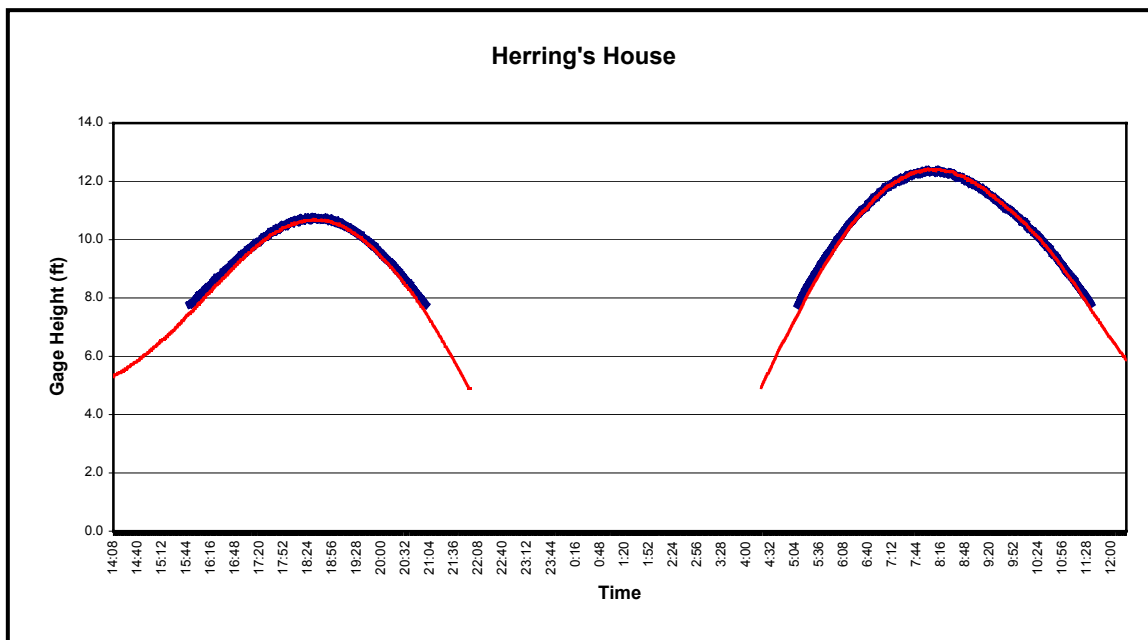
Figure 2b. Tidal regime at Herring's House restoration site (blue line) and in the mainstem Duwamish River adjacent to the restoration site (red line), January 31, 2002.

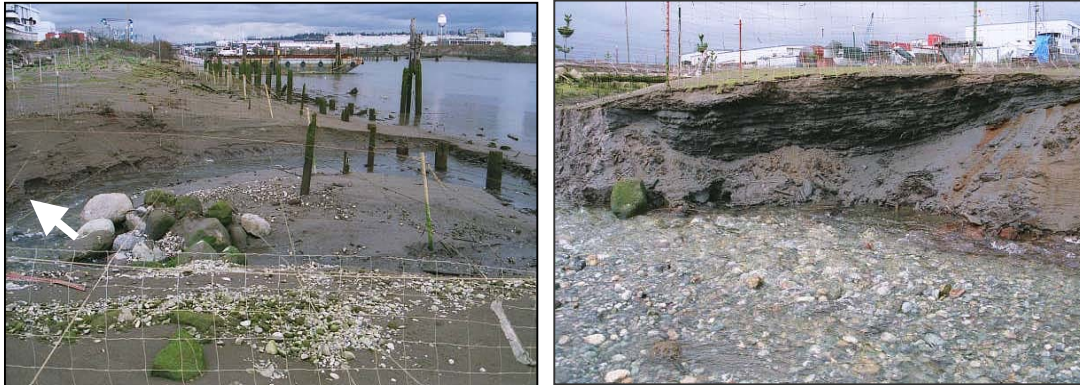
The Hamm Creek site experienced significant erosion of the instream channel to the extent that structural maintenance was implemented. Erosion was observed in the outlet to the Duwamish River during monitoring conducted in 2001. This erosion of the site's unconsolidated sand and mud steadily increased with time, and as a result, the channel continued to head-cut approximately 20 meters up into the estuary by winter 2001. The U.S. Army Corps of Engineers placed large boulders and large woody debris into the channel along the area of erosion during spring and summer 2001. Erosion adjacent to these hard points has continued due to the nature of the substrate in the area (Figures 3a, 3b). One photo point and most of the rebar pins installed to monitor erosion have been lost due to the erosion

occurring at the site. It is unknown at this time whether the observed erosion is part of the natural site stabilization process or will require further action in the future.

Figure 3a. Erosion at mouth of Hamm Creek Estuary, summer 2001. Arrow in site photo (l) indicates angle of view for photo of undercut bank (r).

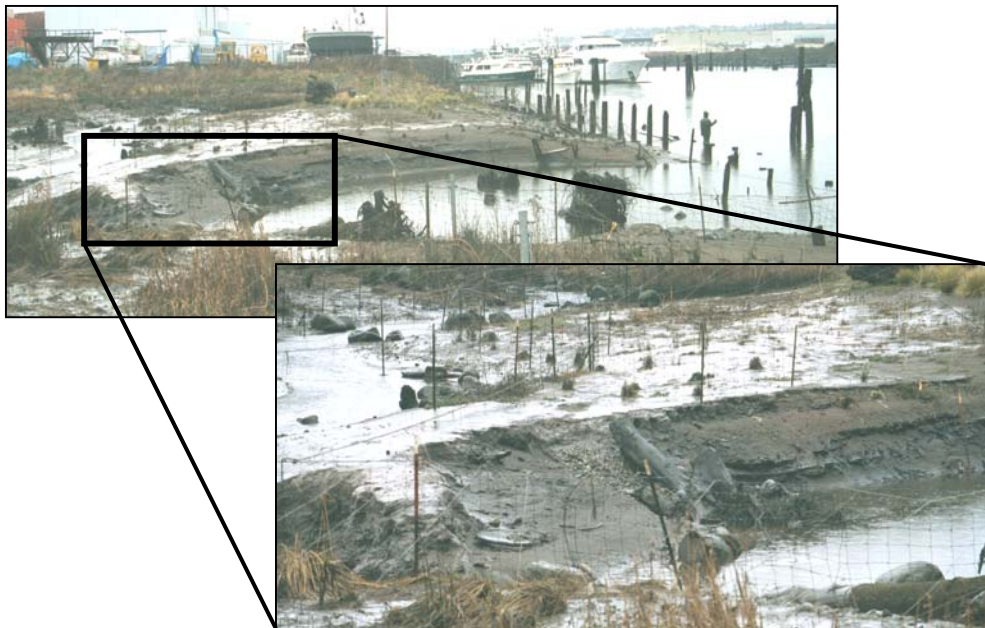
Figure 3b. Erosion at mouth of Hamm Creek Estuary, January 2002, with close-up of eroding area (inset).

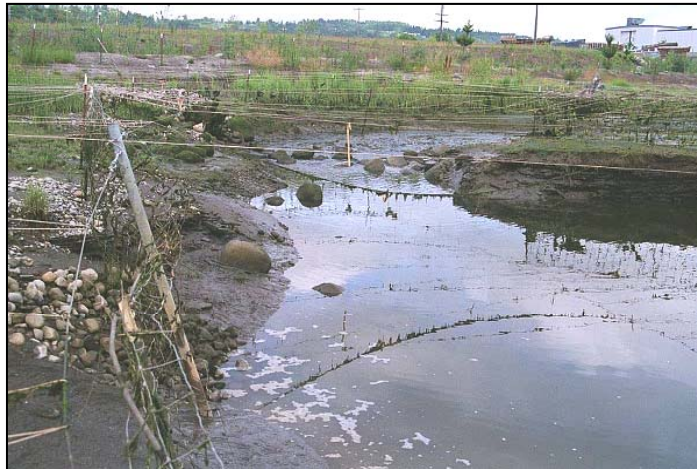
Numbers and/or lengths of transects varied to some extent at each site or subsection of a site, depending on site conditions and topography. The Hamm Creek (Figure 4a) estuarine survey consisted of three transects (5, 13, and 6 plots per transect), while its reference site had two transects (6 and 5 plots). Herring's House (Figure 4b) and its reference site consisted of 2 transects each, with 10 plots per transect at the restoration site and 5 plots per transect at the

Figure 4a. Intertidal area near the mouth of Hamm Creek, with goose exclusion devices, summer 2001.

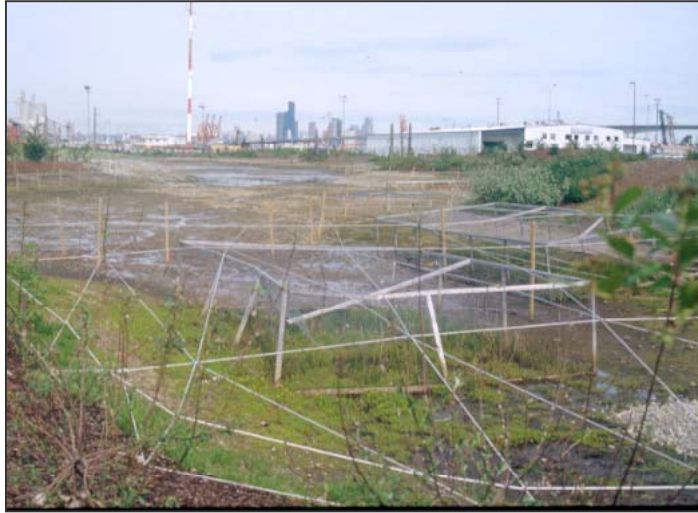
Figure 4b. Intertidal area at Herring's House restoration site, with goose exclusion devices, spring 2001.

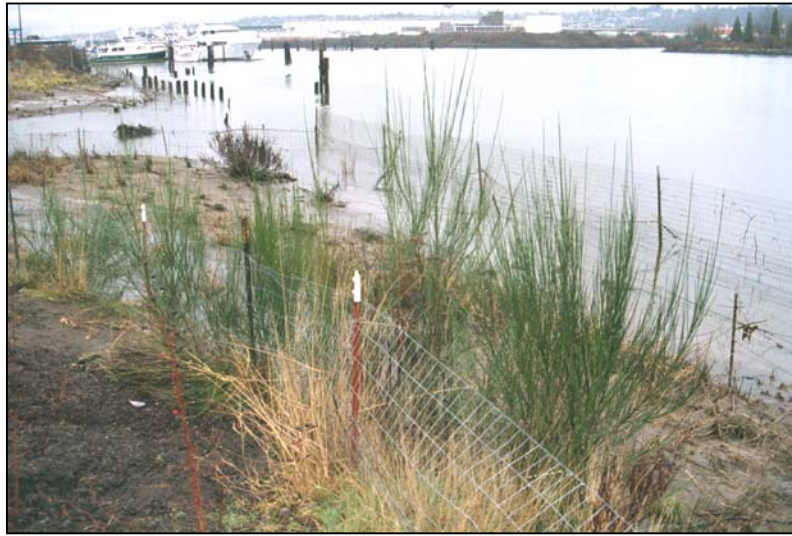
The extent of non-native species establishment was also assessed by recording percent cover of any non-native species present in a transect plot, especially cordgrass (*Spartina* spp.), purple loosestrife (*Lythrum salicaria*), reed canarygrass (*Phalaris arundinacea*), and common reed (*Phragmites communis*), as described by the monitoring plan. While none of these target species were encountered in the Hamm Creek or Herring's House marsh vegetation transects in 2001, another non-native species, Scot's broom (*Cytisus scoparius*) was observed in a single Hamm Creek transect plot, and in the estuarine area outside of the transects (Figure 5a). This species made up approximately 2% of the plot's cover, but a potential future source of this and other invasive plant species can be readily found in the upland and adjacent portions of the marsh (Figure 5b).

Figure 5a. Non-native Scot's broom at Hamm Creek Estuary, January 2002.

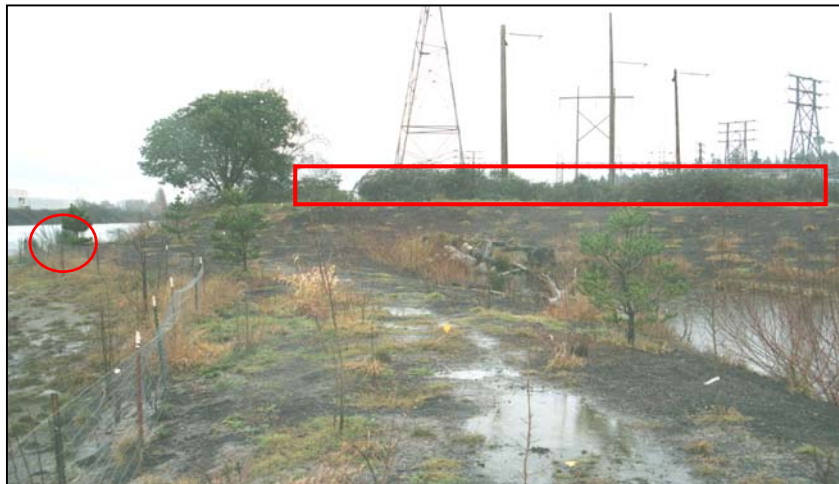
Figure 5b. Non-native Scot's broom at Hamm Creek Estuary (left), and upland, potential Himalayan blackberry seed source (right), indicated by red lines, January 2002.
